# Toward Preventive Maintenance and Rehabilitation of Bridges in Cameroon

## ABSTRACT :

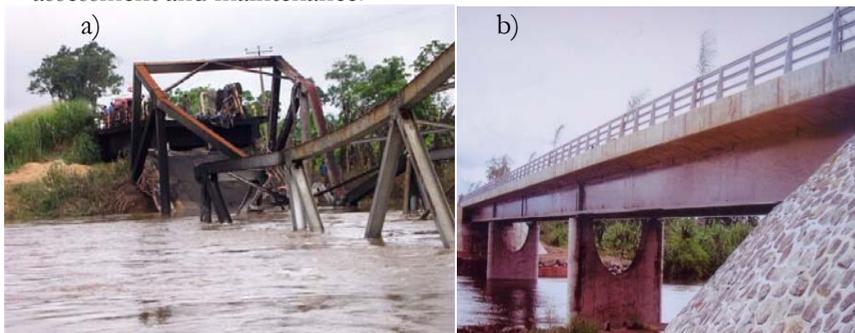
**Figure 1:**  
(a) The collapsed former Mungo steel bridge and  
(b) the reconstructed new one.

The vast majority of bridges in Cameroon were built more than 50 years ago and 54% of the country bridges network is relatively in a bad state [1]. With the high demand of heavy axle loads in the country to carry goods from the inland to sea ports and vice-versa, many bridges are subjected to loads far higher than those envisaged during the design stage. The poor state of these bridges is worsened with the insufficiency of maintenance investment so that many of existing bridges have significantly deteriorated over their years of service as seen in Figure 1 with the collapse of the former Mungo bridge in July 2004.

This graph shows that within a period of 100 years, the failure indices decreases from 4 to 1 (figure 4.Y1). The bridge being made up of redundant elements, the threshold security, or the allowable reliability index, that corresponds to the time when the bridge cannot withstand the designed traffic load is  $n=50$  years or simply  $\beta=2$ . This implies that below this ultimate value one must implement adequate maintenance procedures to avoid an unexpected failure as the one depicted in figure 1.a). It will therefore be

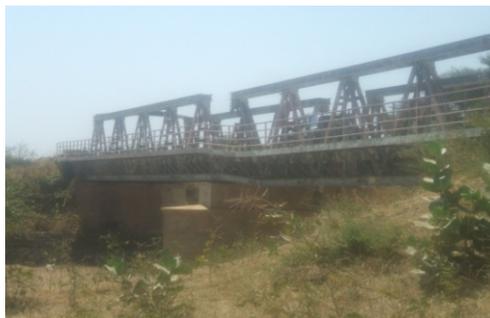
Figure 3: the former bridge over the Mayo-Boula River (a), and its numerical failure model (b)

The superstructure of the former bridge over the Mayo-Boula River was a two-span steel Warren truss supporting a one-line highway concrete board, 4.2 meters wide with two sidewalks, resting on transverse beams connecting the two truss systems of the bridge. Steel truss elements were IPE350 and grade S235 from the EUROCODE 3 standard. The total span of the bridge was 50 m and consisted of two continuous spans of 25 m each, resting on a middle pier and two abutments. The bridge was constructed on the colonial era before the year 1960, and according to residents of Mayo-Boula, the bridge lasted 50 years before its decommissioning in 2009.

failure, fatigue due to traffic load and breaking that can be seen in figures 2.c) and 3.b). The **breakage** of truss elements, due to a chock with an oversized trailer carrying a bulldozer in 2004, caused a 40 cm axial deformation of the bridge system as seen in figure 3.a) and forced highway authorities to reduce the running speed and circulation of heavy trucks on the bridge [13, 14, 18] for five years under high risk of failure.

Various elements of the bridge system being classified into six groups of structural elements subjected to induced traffic loading, the Wöhler characteristic diagrams [14] is drawn for each elements group using results of stress analysis due to specified loadings, and thereafter the group performance or reliability diagram. From the performance diagram of each group we deduce the reliability index diagram of the bridge subjected to degradation due to fatigue of a given number of its constitutive elements described in figure 3.b) with computational results depicted in figure 4.

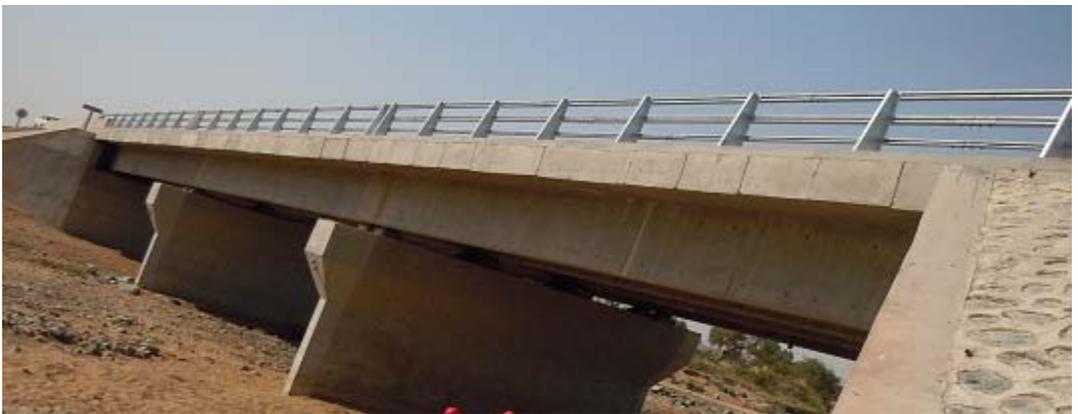
**Figure 5:** The reinforced concrete new bridge over the Mayo-Boula River

The new bridge (Figure 5) over the Mayo-Boula River is a three span reinforced concrete platform made of four precast simple supported beams spanning 17 m with a 0.80 m×1.50m cross-section each, and over which an in-situ 10-m wide board was casted, with 1.5 m sidewalk at each side. The running surface is a 8-cm thick bituminous concrete [15]. Specifications of the new bridges show that all deck concrete shall have a minimum compression stress of 25 Mpa and 2.1 MPa in tension considering that the cement mean stress was 35 MPa, with steel Reinforcement strength taken as  $f_y=460$  MPa and the cement concentration was 400 Kg/m<sup>3</sup>.
